Department of Defense Corrosion Prevention and Control Program

Demonstration of Three Corrosion-Resistant Sustainable Roofing Systems

Final Report on Project F08-AR02

June 2013

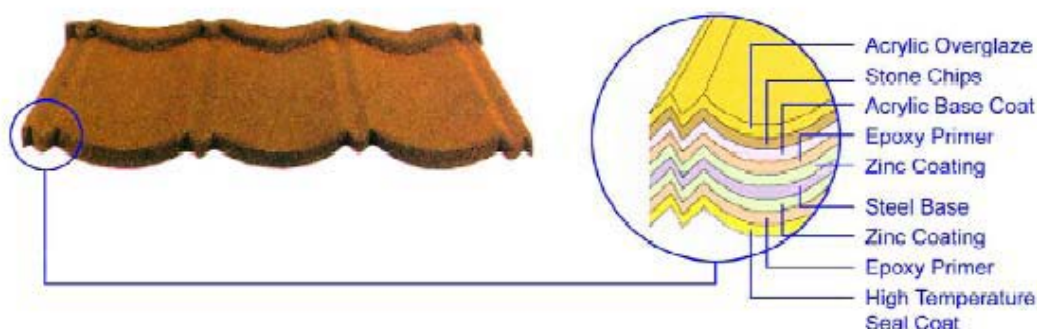
Figure 1. Material layers in stone-coated metal shingle. Source: www.decra.com.

The stone coated metal shingle used in this demonstration is manufactured by Decra Roofing Systems, Inc.* They derive their corrosion resistance from multiple coating layers, which include a zinc coating over a steel substrate, epoxy primer over the zinc coating, and a layer of stone chips encased in a corrosion- and UV-resistant acrylic binder (Figure 1). The stone chips provide additional protection from heat and abrasion. The “fawn grey” color that was chosen is ENERGY STAR® qualified (<http://www.energystar.gov>) and has an initial solar reflectance of 0.25 and unchanged reflectance of 0.25 after 3 years of exposure. The shingles have a very good initial thermal emissivity value of 0.97. This product, when installed on a pitch of 4 in. over 12 in. or more, qualifies for a 50-year warranty from the manufacturer with protection against damage from hail and wind up to 120 mph.

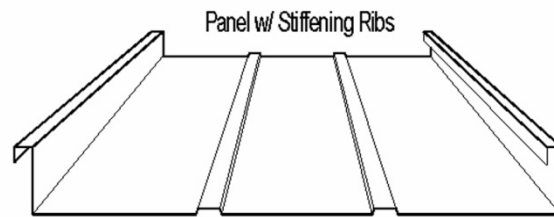
Figure 5. Replacement panel profile.
Source: Construction Metal Products, Inc.

The Construction Metal Products CMP S-2500 18 in. panel SSMR system was selected for the demonstration.* The 26-gauge galvalume-coated steel panel has an additional protective coating comprised of a high performance resin (70% polyvinylidene fluoride (PVDF)) and a "cool pigment" (PPG Industries, Inc. DURANAR ULTRA-Cool). The coating provides optimal corrosion resistance. The color, sierra tan, was chosen to match the surrounding building architecture. It has an initial solar reflectance of 0.49, a solar reflectance of 0.45 after 3 years of exposure, and an emissivity value of 0.83. The dark rubber EPDM membrane already in place had a solar reflectance of 0.06 and thermal emissivity of 0.06. The panel profile and description can be found in Figure 5.

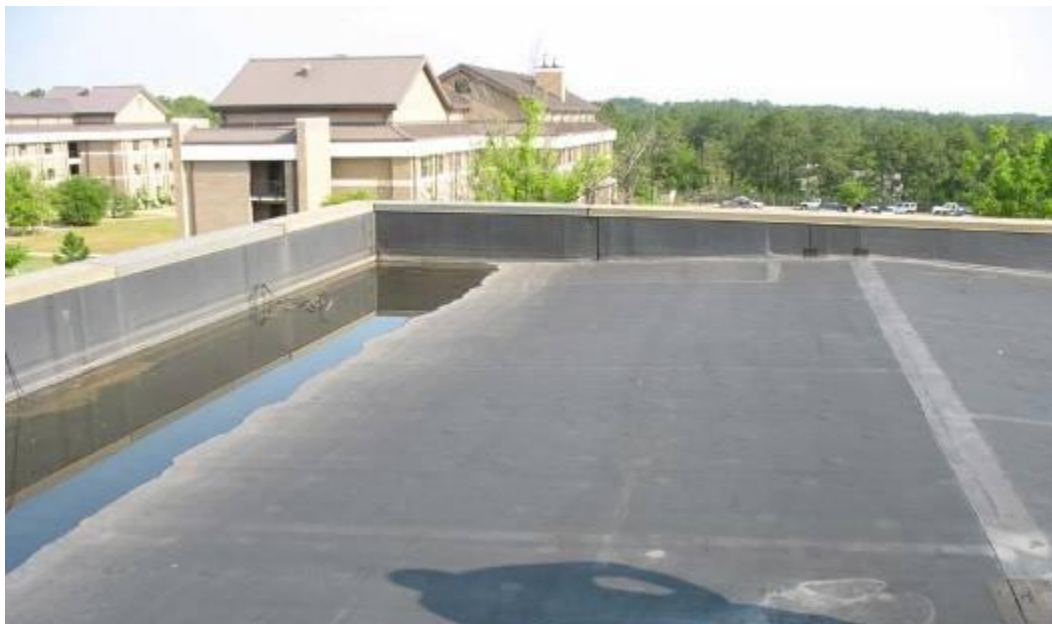
Figure 6. Ponding on pre-demonstration roof due to clogged drains.

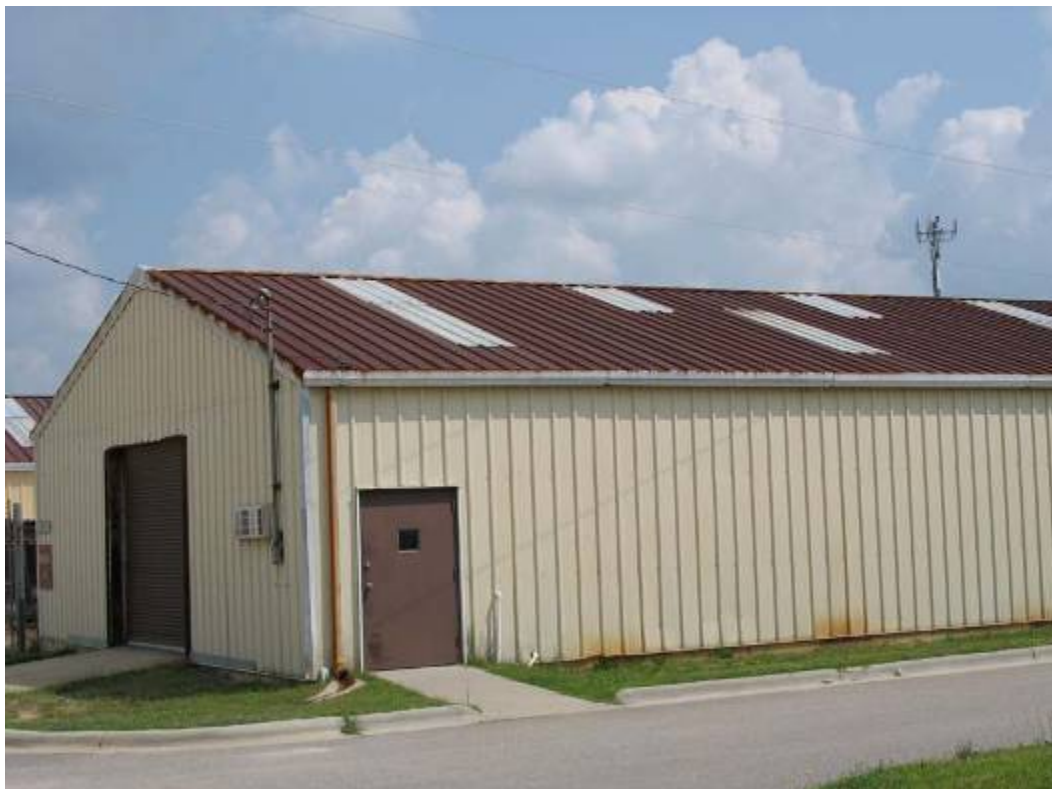
Figure 7. Pre-demonstration metal roof on one of the project buildings.

One such product, Tuff Span® from Enduro Composites*, was selected to demonstrate as a replacement for severely corroding metal roofs on three pre-engineered metal buildings (Buildings 3-1735, 3-1736, and 3-1737). All three buildings, similar in size and construction, are used for storage of grounds maintenance equipment (Figure 7). The FRP replacement panel has a corrugated profile (Figure 8) and is composed of a lightweight multi-layer material that is corrosion and chemical resistant (Figure 9). The product is expected to provide improved corrosion resistance and better protection against water intrusion that can cause damage to the material and equipment stored in the buildings.

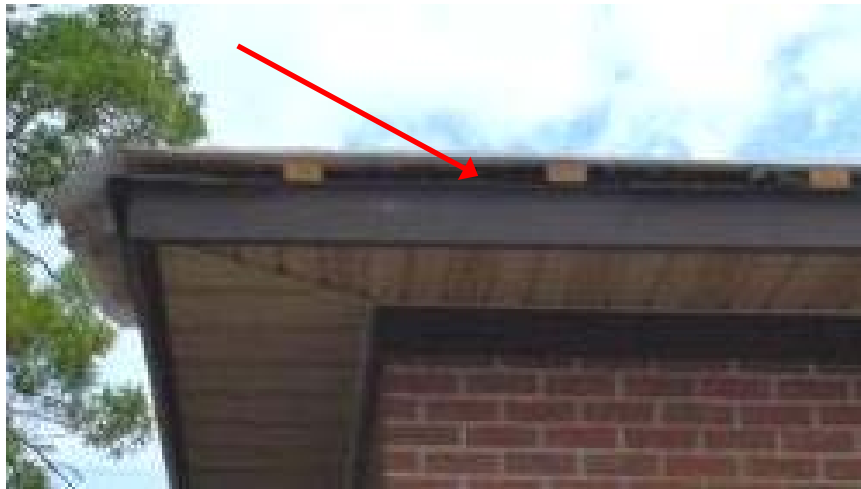
Figure 11. Air gap between existing and new roof, Building 8-3846.

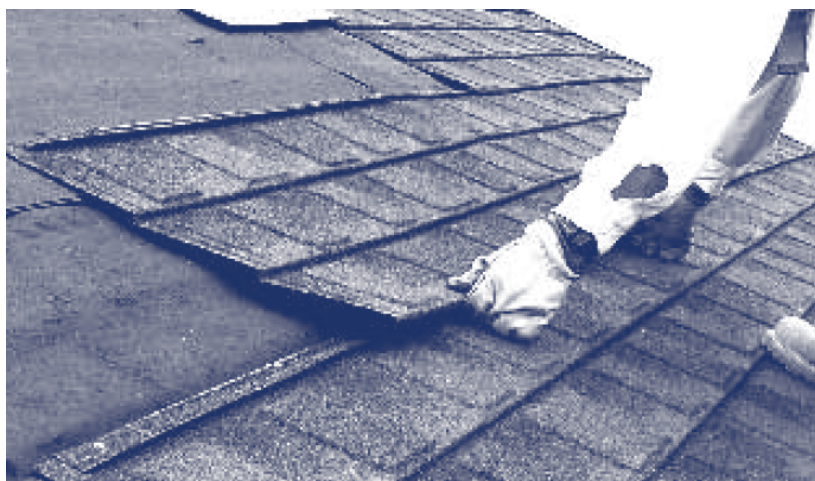
Figure 12. Manufacturer's illustration of panel positioned to mate with the clip lock on panels in the course below.

The new sheathing was covered with one shingled layer of asphalt-saturated organic felt underlayment (ASTM D 228, Type 1). The stone-coated shingles were installed in accordance with the procedures recommended in the manufacturer's literature. The first rows of shingles, at the eave, were attached to an integrated starter clip/drip edge. The bottom edges of subsequent rows were locked into place with clips that are formed into the top edges of the preceding rows. This procedure is illustrated in a photo from the manufacturer's literature (Figure 12). As directed in the manufacturer's installation guidelines, the right side of each panel was compressed in order to interface with the side-lap locking mechanism formed into the left side of the adjoining panel at its right. Once each panel was locked into place, it was attached to the sheathing along the upper edge with four corrosion-resistant #8 hex-head screws.

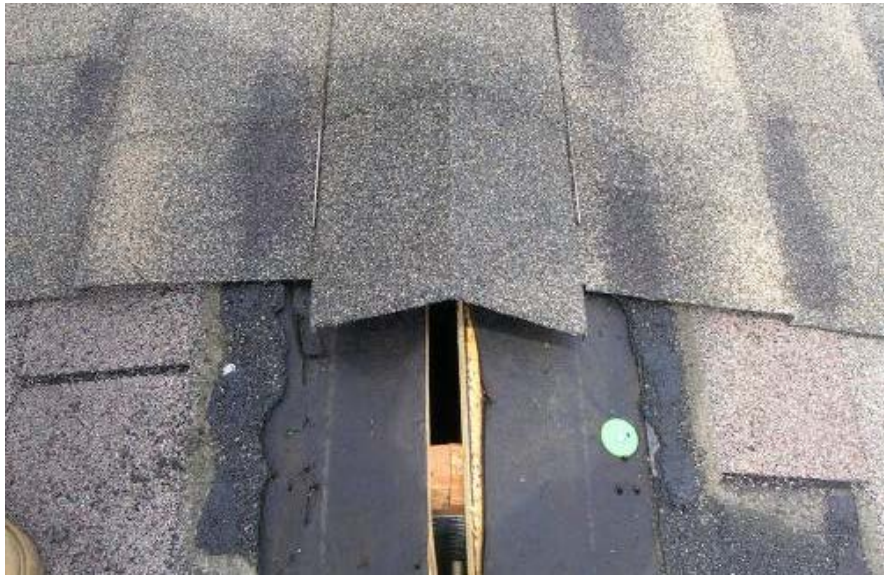
Figure 15. Ridge vent mockup for Building 3-2631.

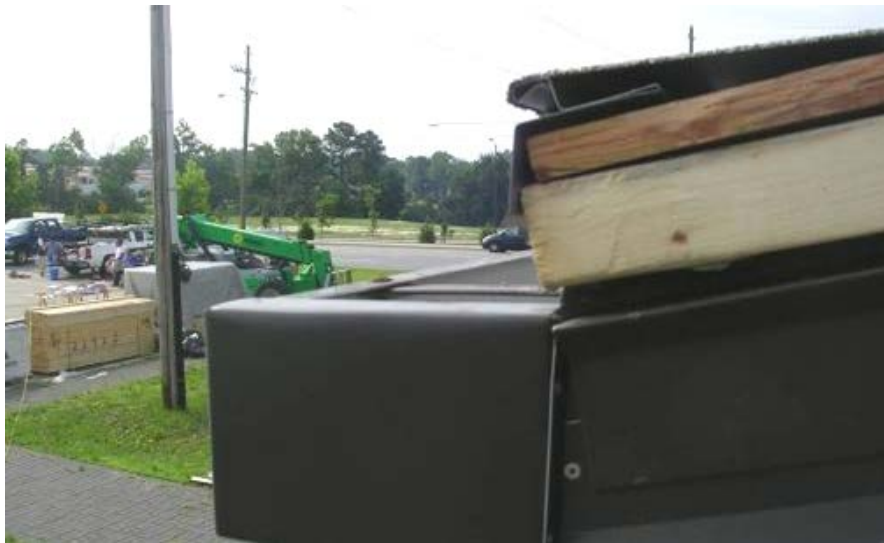
Figure 16. Completed roofing system gutter detail, Building 3-2631.

With the new roofs installed on the buildings, all gutters were replaced to their original configuration. During the system installation on Building 3-2631, the general contractor noticed the existing gutters were not being raised in conjunction with the new roof, resulting in a drop of more than 2 in. from the new roof to the gutters (Figure 16).

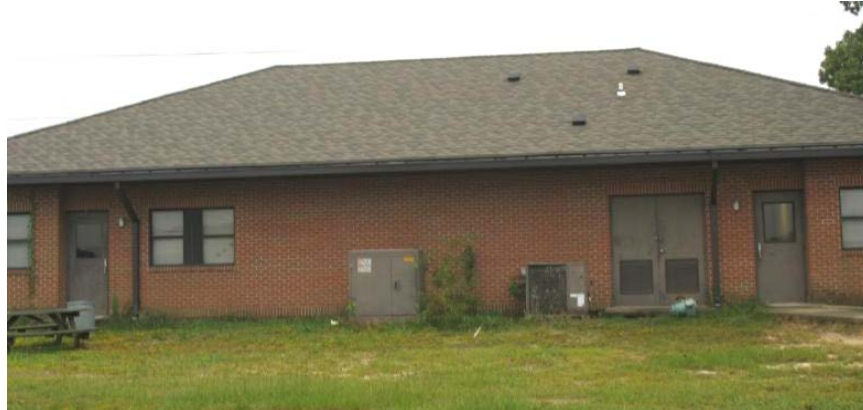
Figure 17. Completed roofing system Building 8-3846.

The subcontractor's roofing engineer analyzed the configuration. Using the design rainfall conditions, analysis indicated that the gutter location was acceptable and able to contain runoff. These calculations are shown in Appendix B. The completed roofing system for Building 8-3846 is shown in Figure 17.

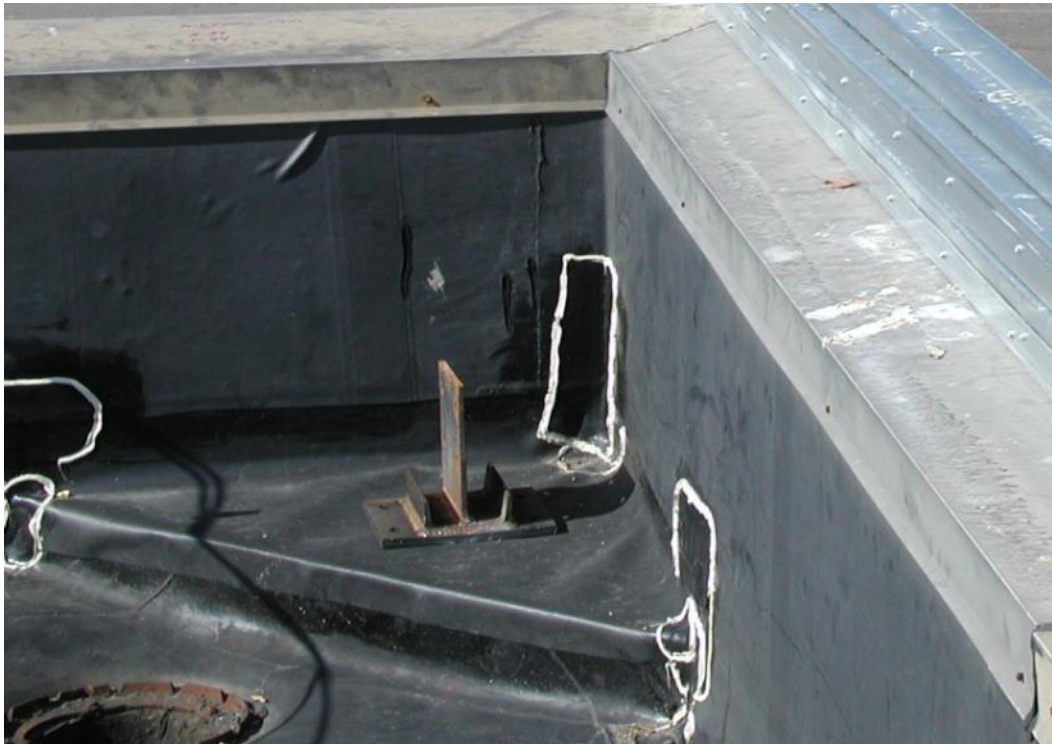
Figure 19. Completed construction of pad and anchor bracket at corner.

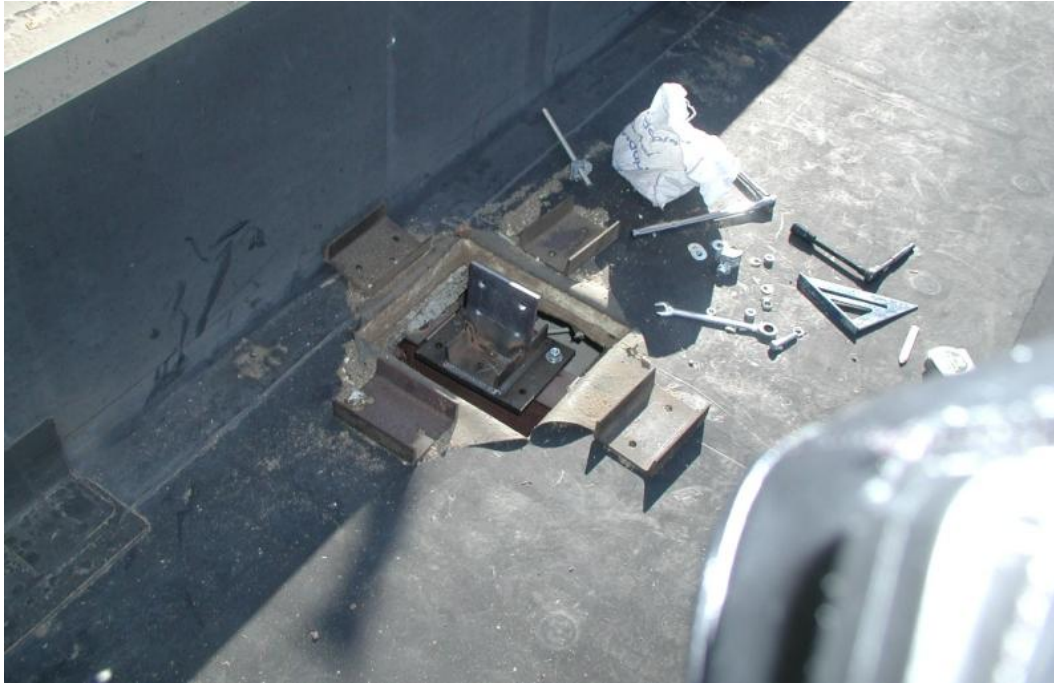
Figure 20. Attachment of anchor bracket to roof beam at perimeter wall.

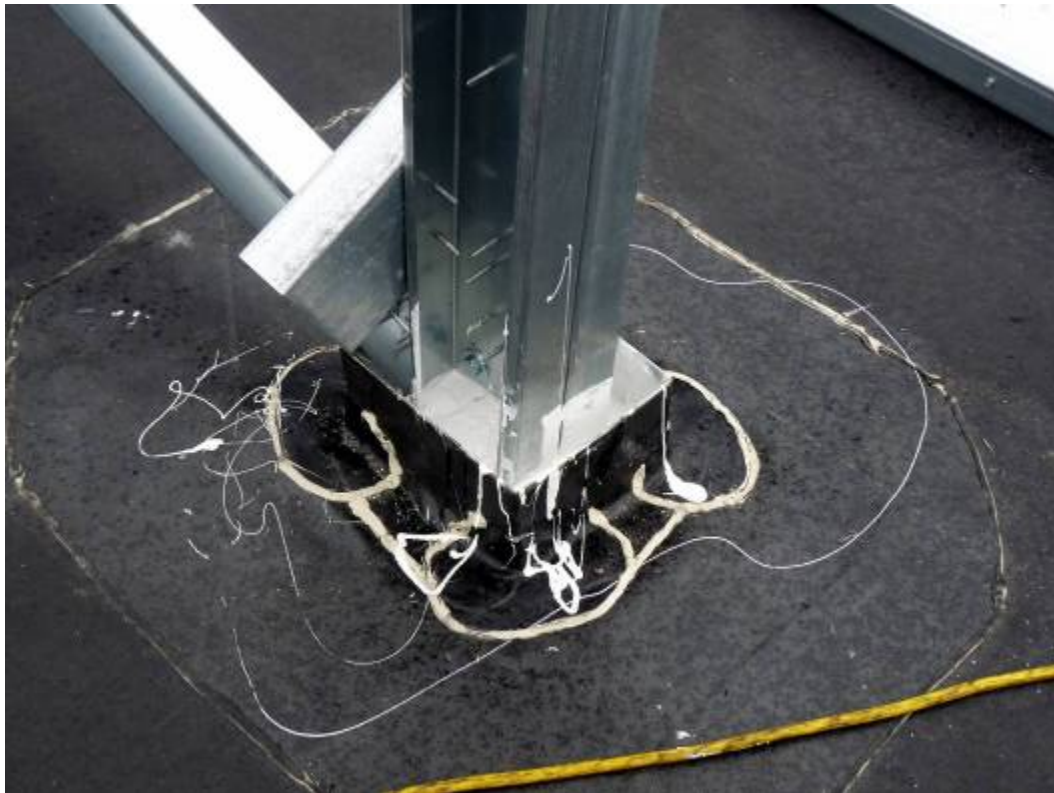
Figure 21. Pitch pan being constructed around roof penetration at attachment point.

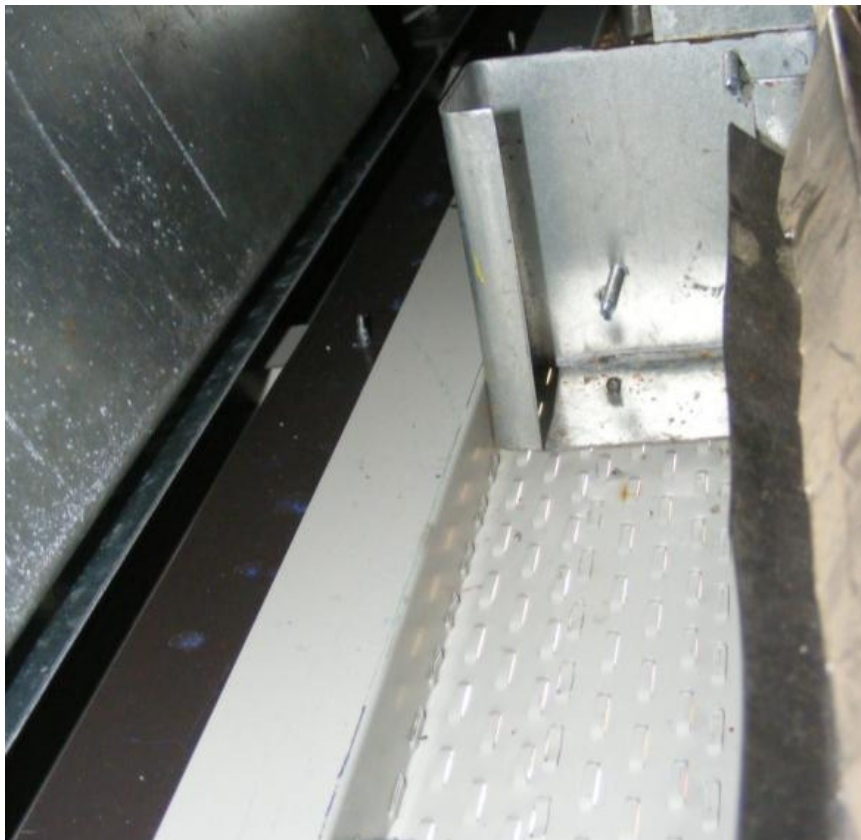
Figure 29. Ventilated soffit panel, attic interior view.

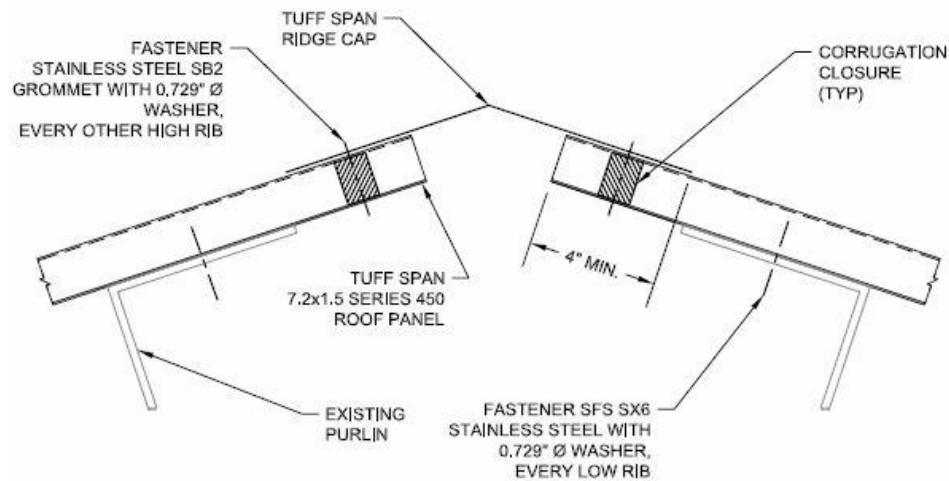
Figure 33. Ridge cap detail.

All fasteners, being made of stainless steel, have superior corrosion resistance. The grommet feature inhibits leakage at the fastener. Other system features that promote watertightness included a nonshrinking, nonhardening butyl tape field-applied in the lap area of all adjoining panels (Figure 34) and the placement of preformed foam panel closures at the openings under the panels located at the eaves.

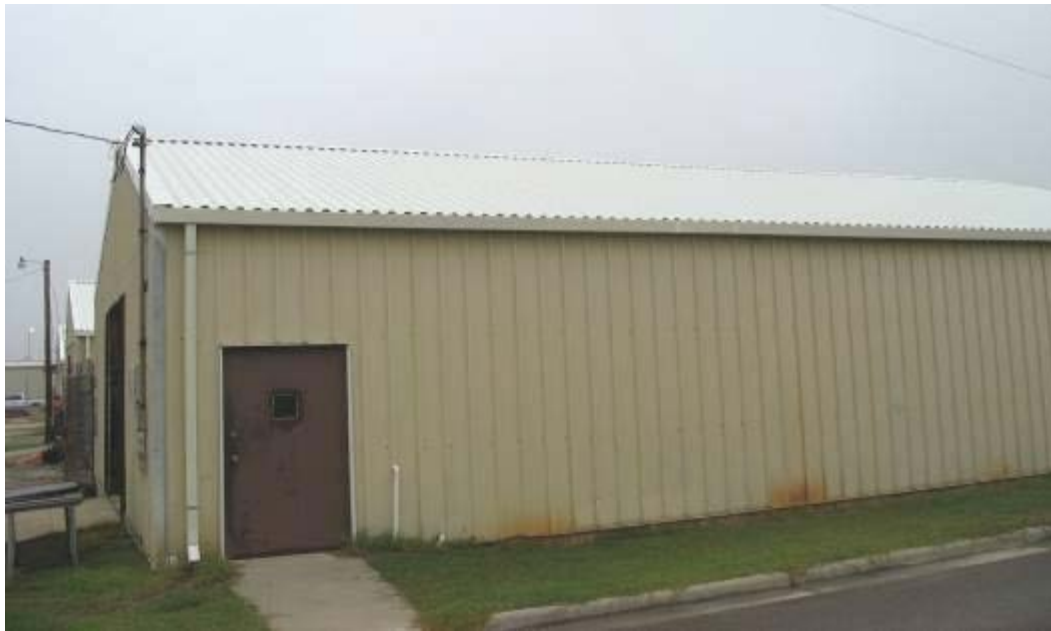
Figure 35. View of completed FRP panel roof system.

Design drawings for the roofs are provided in Appendix D. The completed roofing system on one of the buildings is shown in Figure 35.

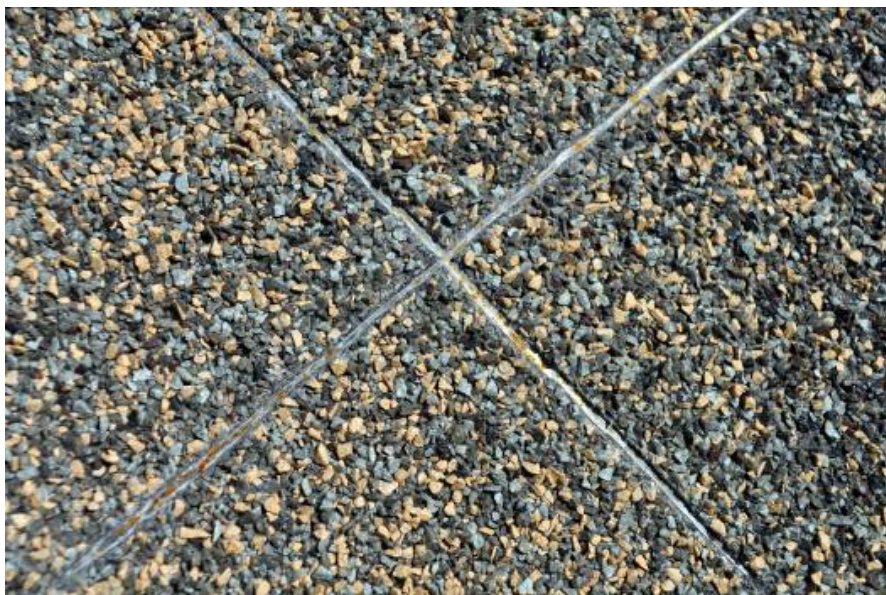
Figure 38. Corrosion in scribed metal shingle coupon.

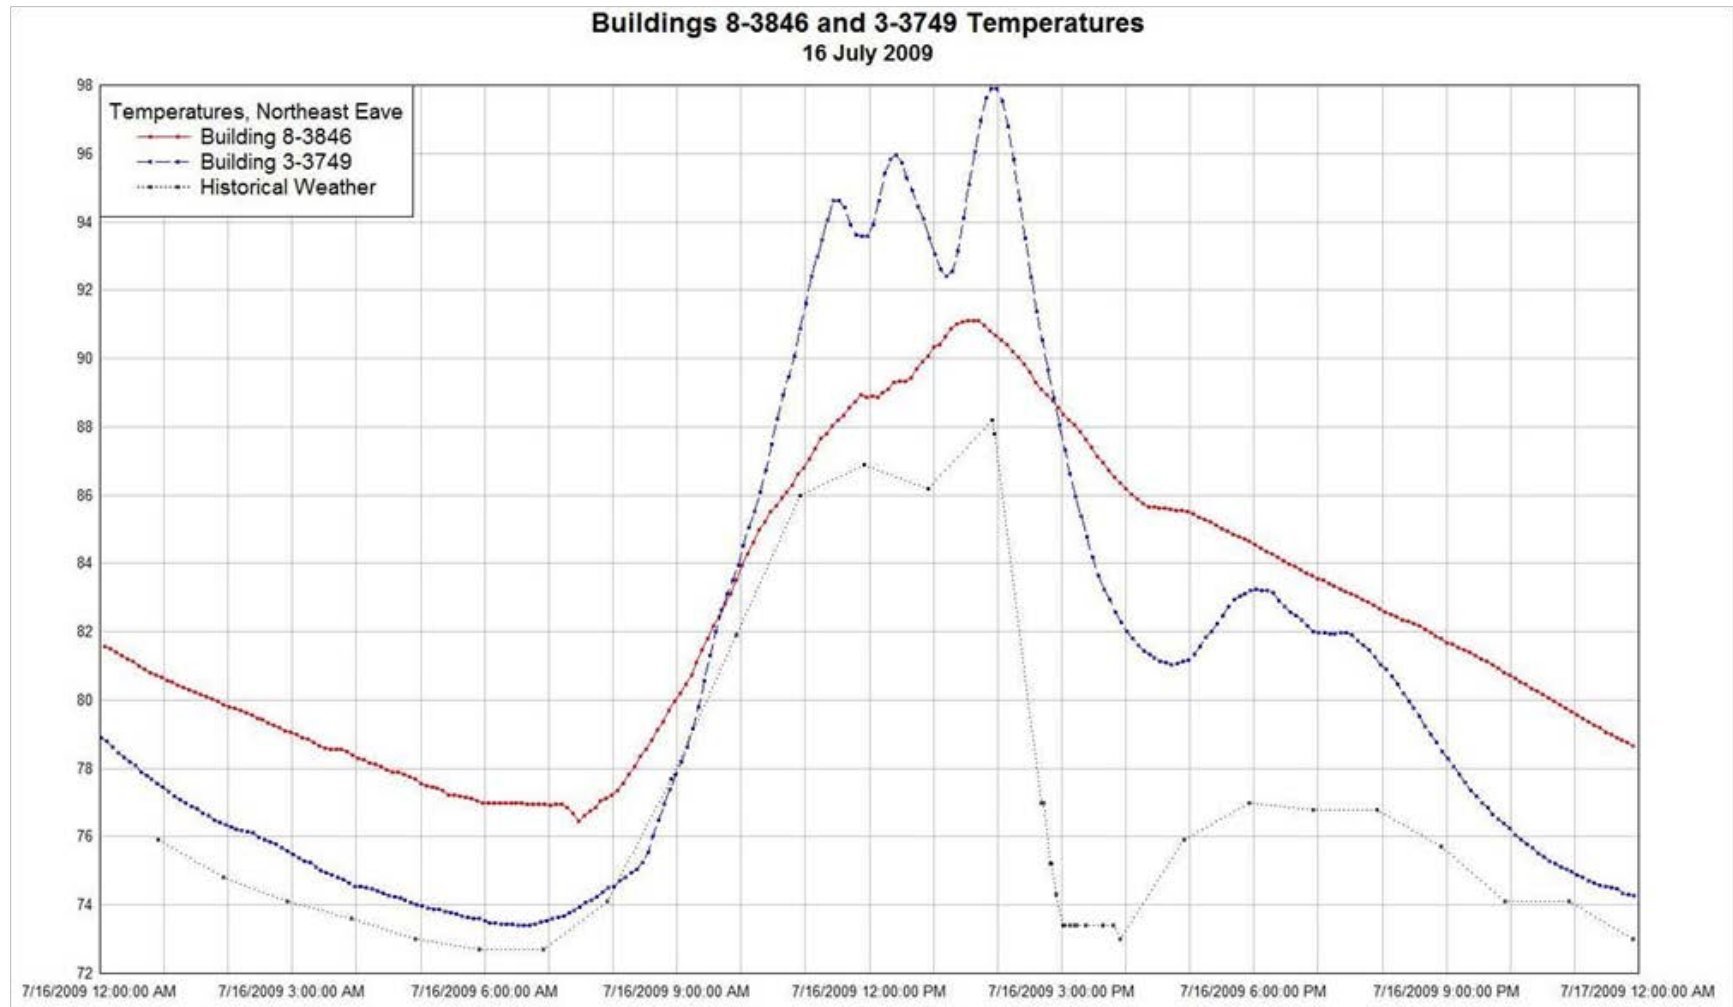
Figure 39. Temperature comparison between Buildings 8-3846 and 3-3749, northeast eaves (16 July 2009).

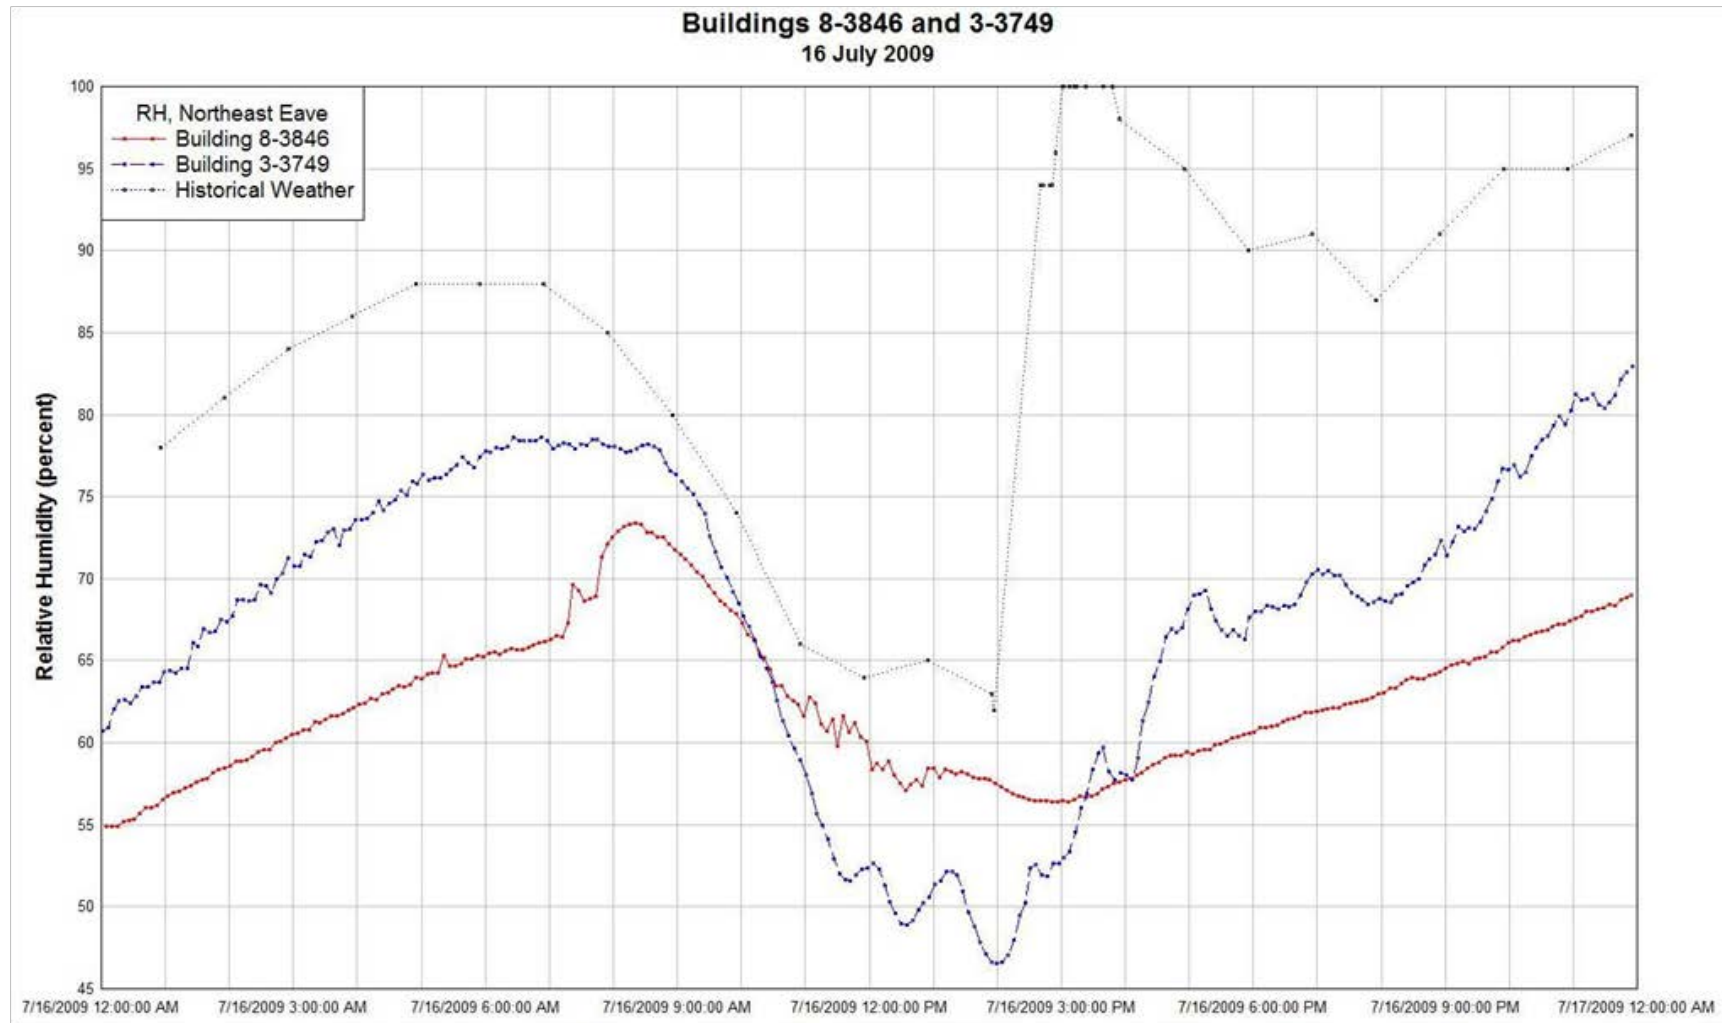
Figure 40. Relative humidity comparison between Buildings 8-3846 and 3-3749, northeast eaves (16 July 2009).

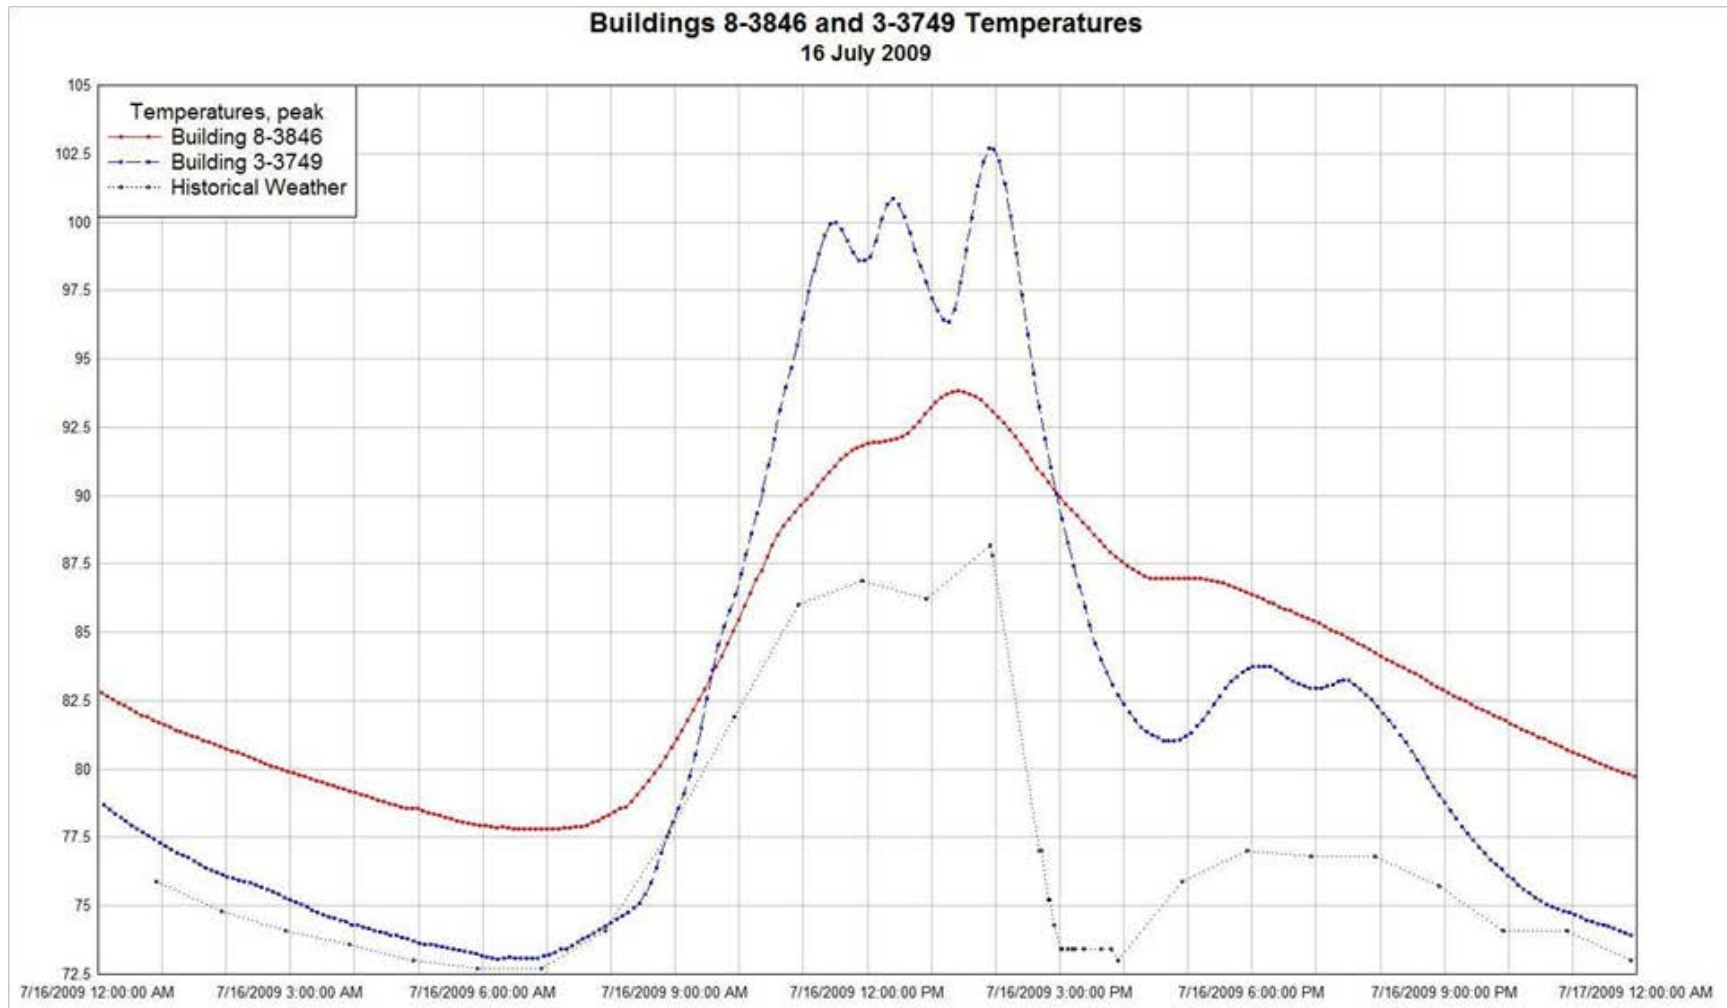
Figure 41. Temperature comparison between Buildings 8-3846 and 3-3749, attic peaks (16 July 2009).

A plot of the recorded temperature data taken on that same day (16 July 2009) from a different set of attic sensors located at the northern peaks of Buildings 8-3846 and 3-3749 (the same buildings) is shown in Figure 41. As seen at the northeast eaves, the plots show the attic space of the metal-shingle roof with ASV changing in temperature at a slower rate than that of the control building. Also, the peak attic temperature during the day for the demonstration building is about 10 °F lower than was reached in the control building. These results indicate a potential for reducing cooling energy requirements during peak demand times.

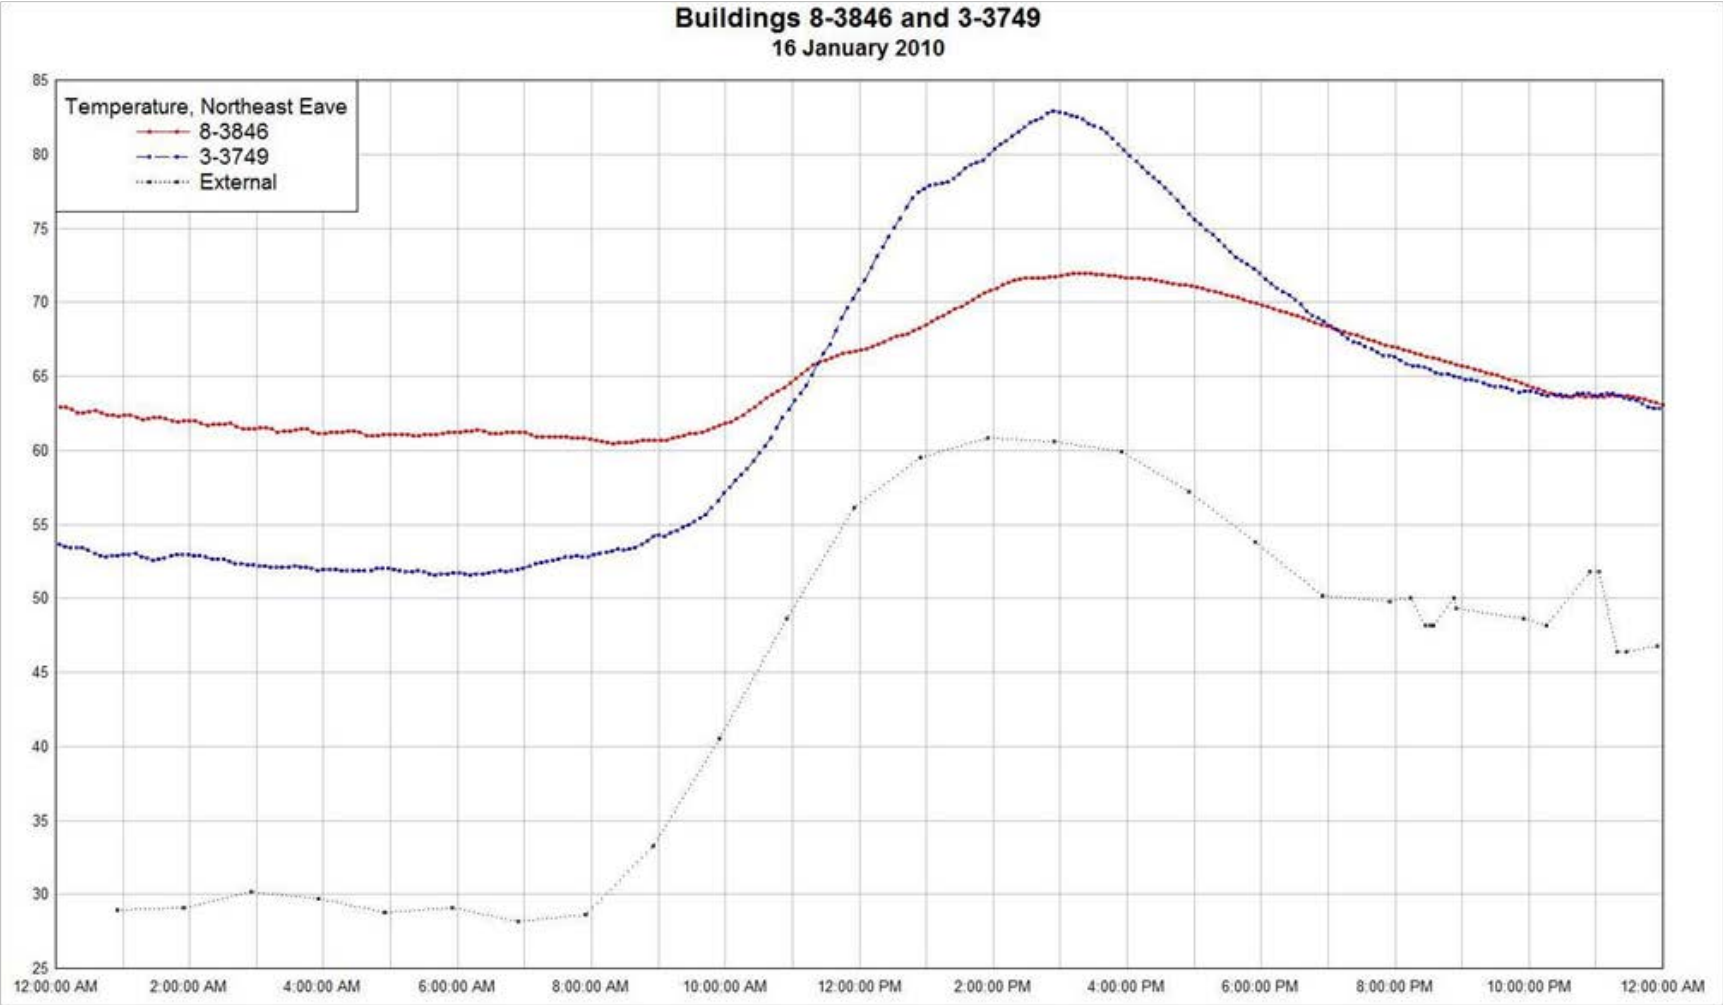
Figure 42. Temperature comparison between Buildings 8-3846 and 3-3749, northeast eaves (16 January 2010).

In addition to examining the attic conditions during a summer day, the temperatures on a winter day (16 January 2010) were also examined. Figure 42 shows a plot of the attic temperatures at the northeast eaves on the two buildings on 16 January 2010. In this case, the demonstration building with the metal shingles and ASV held a higher attic temperature during the night. But as the daytime ambient air warmed up, the attic temperature fell below that of the control building. If the attic space is able to serve as a thermal buffer during the nighttime, it is possible that heating costs may be reduced during the winter. The same inference would indicate that heating costs could increase during the daytime. As seen for the summer comparison, the attic temperatures for the building with the stone-coated metal shingle and ASV change at a slower rate as compared to the attic of the control building.
